PENNSYLVANIA  
**FISHPOND DAM**

NDS ID NO. PA-899  
DER ID NO. 19-81

PHASE I INSPECTION REPORT  
NATIONAL DAM INSPECTION PROGRAM

NAME OF DAM	Fishpond Dam
STATE LOCATED	Pennsylvania
COUNTY LOCATED	Columbia
STREAM	Unnamed tributary to Roaring Creek
DATE OF INSPECTION	November 20, 1979 & April 8, 1980

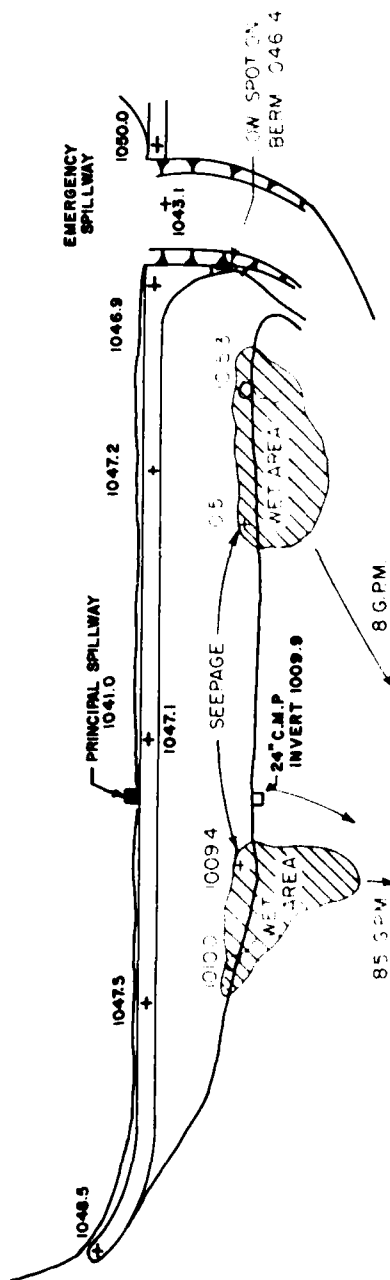
FISHPOND DAM  
Scale 1"=100'

RESERVOIR  
+ 1038.3

2. Raise the height of the earth berm to the right of the emergency spillway to a minimum of top of dam elevation (See page A-12).
